MMOD Risk/External Inspection Needs for Re-entry TPS

In Space NDI Workshop - 29 February, 2012
NASA Johnson Space Center

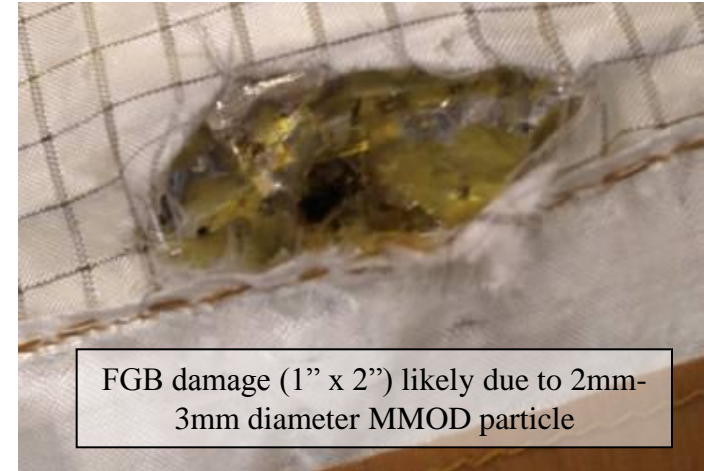
FGB damage (1" x 2") likely due to 2mm-3mm diameter MMOD particle

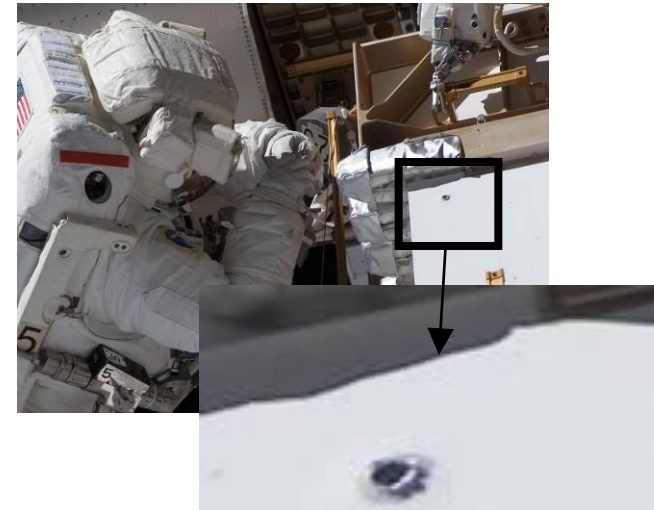
P6 radiator damage noted during STS-118 (0.75" diameter) likely due to 3-5mm diameter x 1mm thick MMOD particle

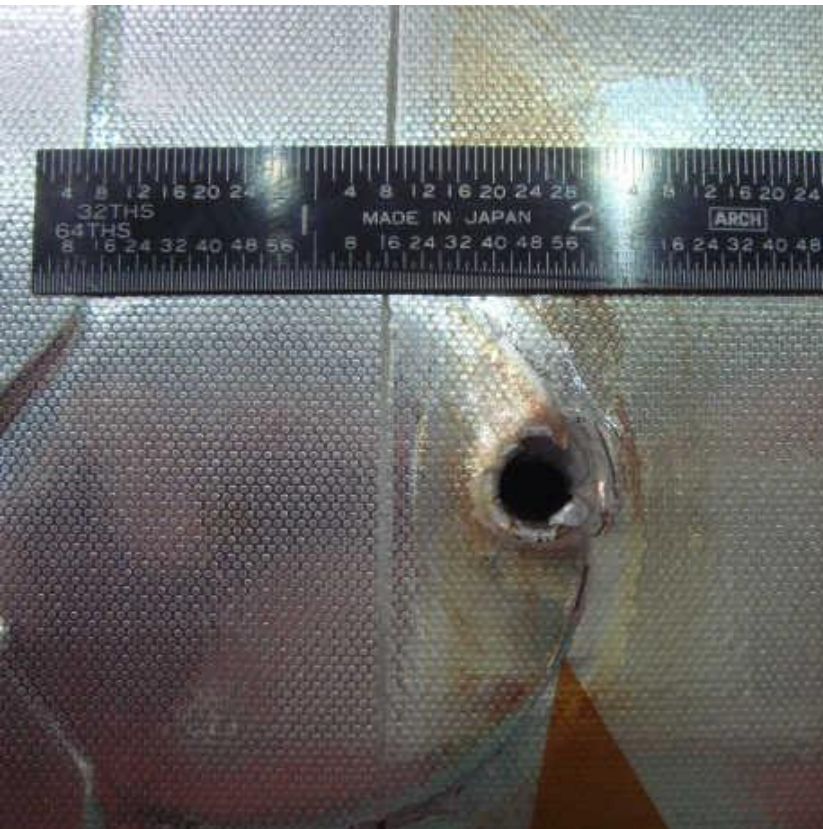
Front Facesheet Damage

- Hole (0.216 inches diameter) through front facesheet (and doubler), and 0.5in to 0.75in diameter in back facesheet. Also went through thermal blanket behind radiator (two places) and left deposits on payload bay door.

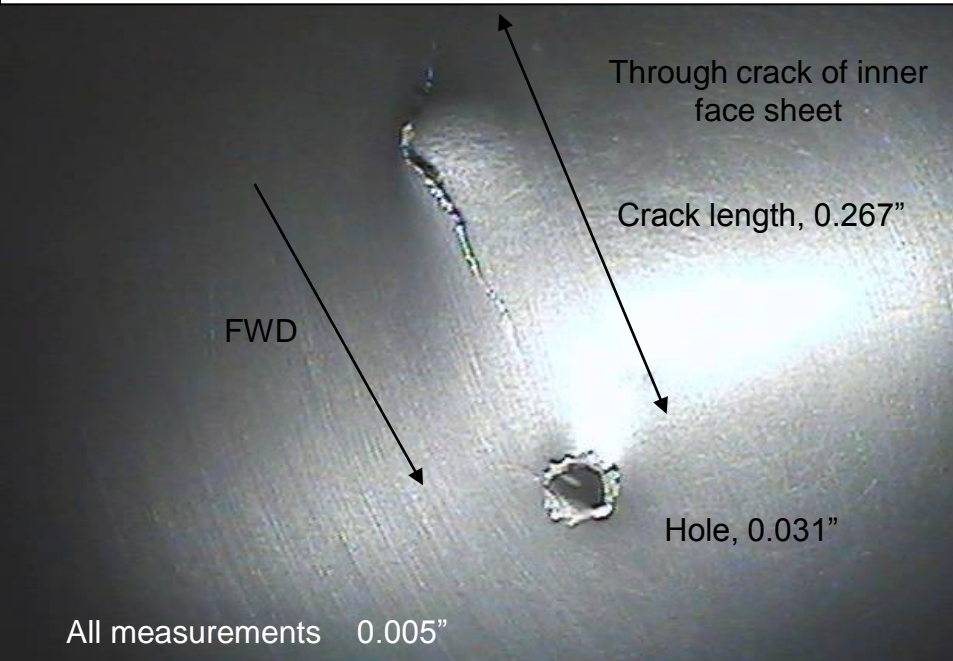
Inner face sheet damage

SEM-EDX analysis indicates damage caused by orbital debris: ceramic fiber-organic matrix composite (circuit board)

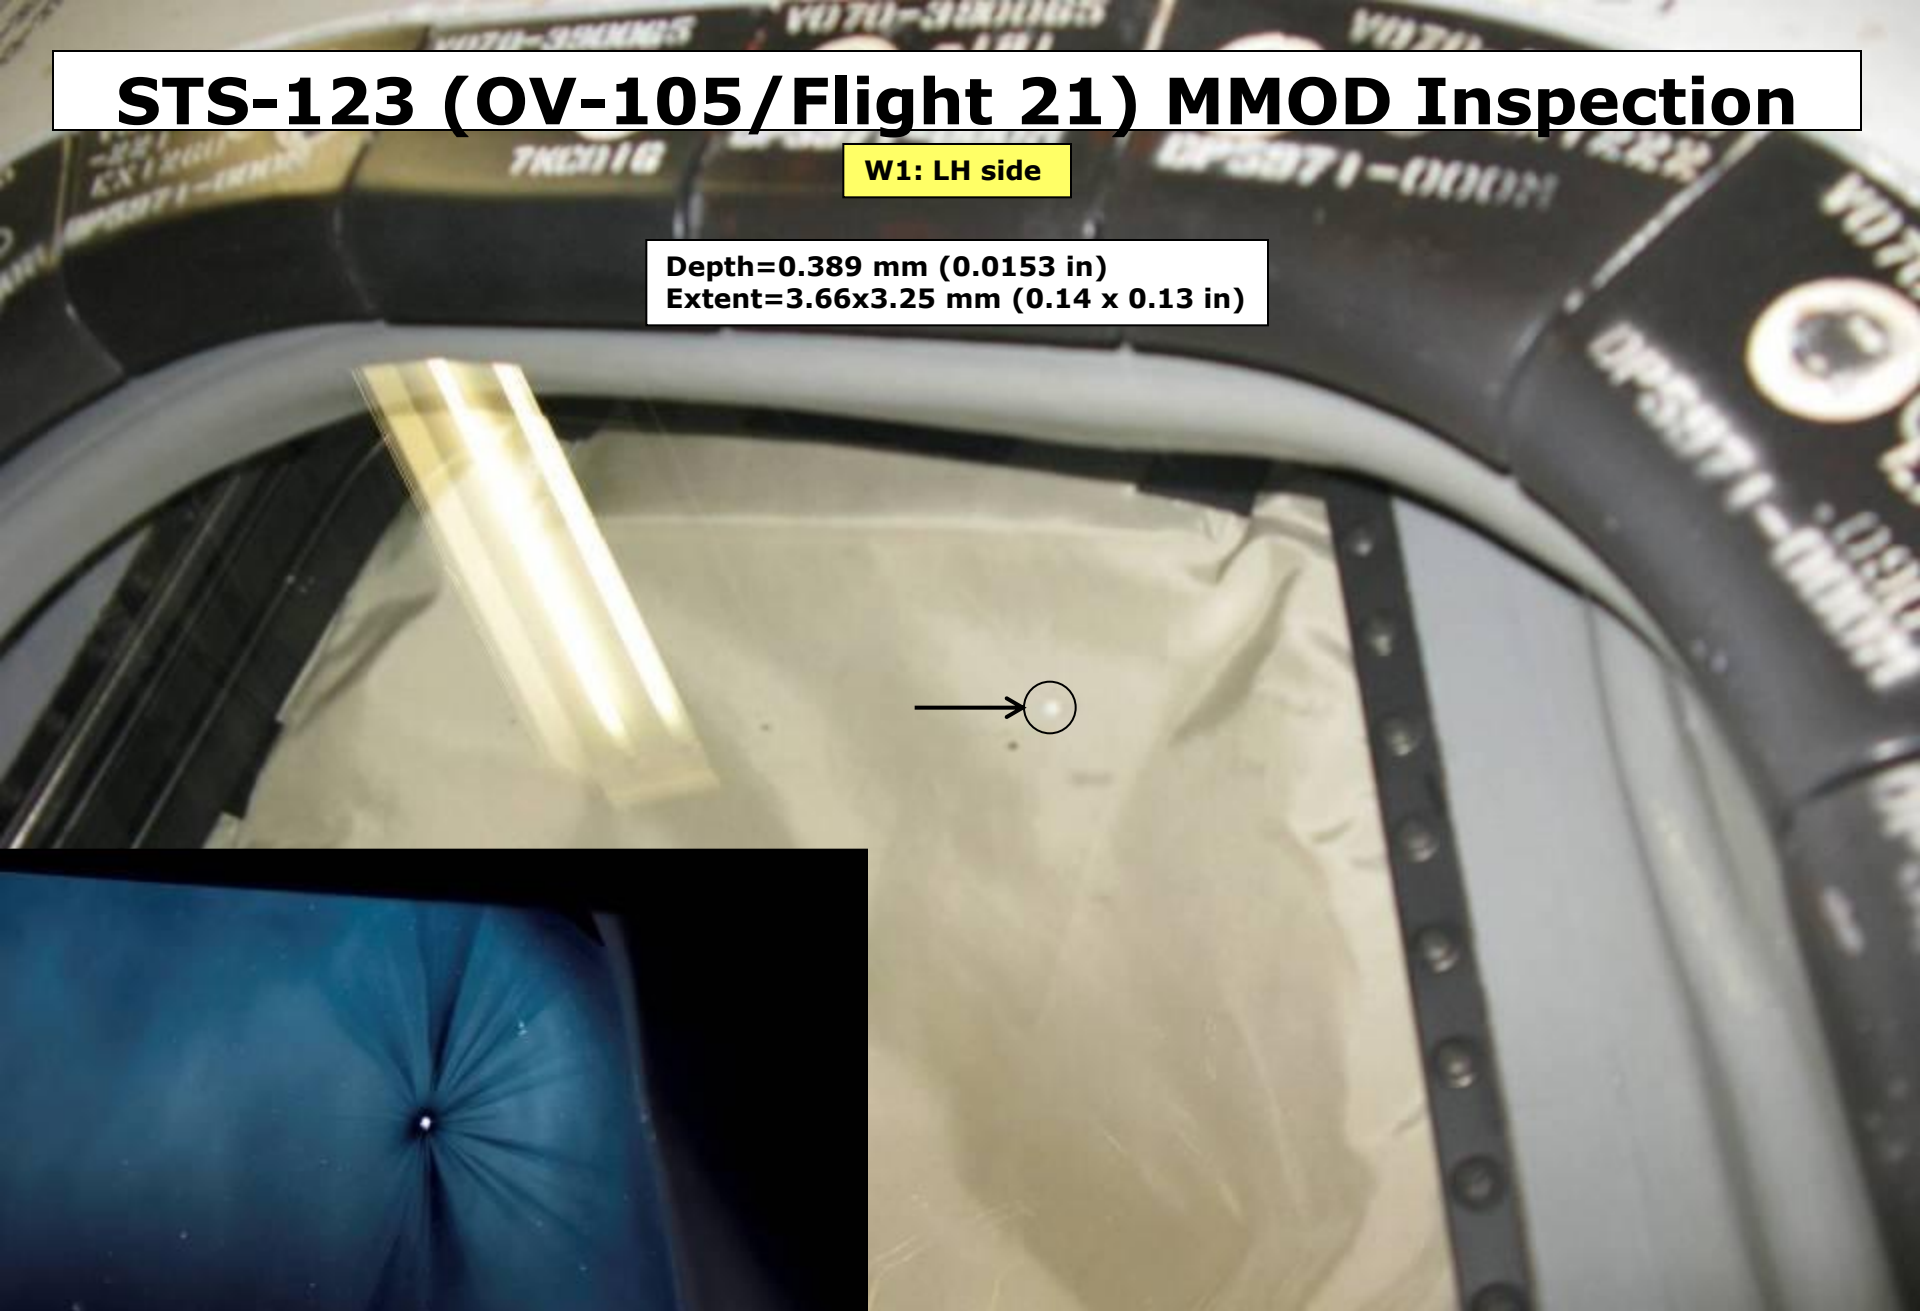
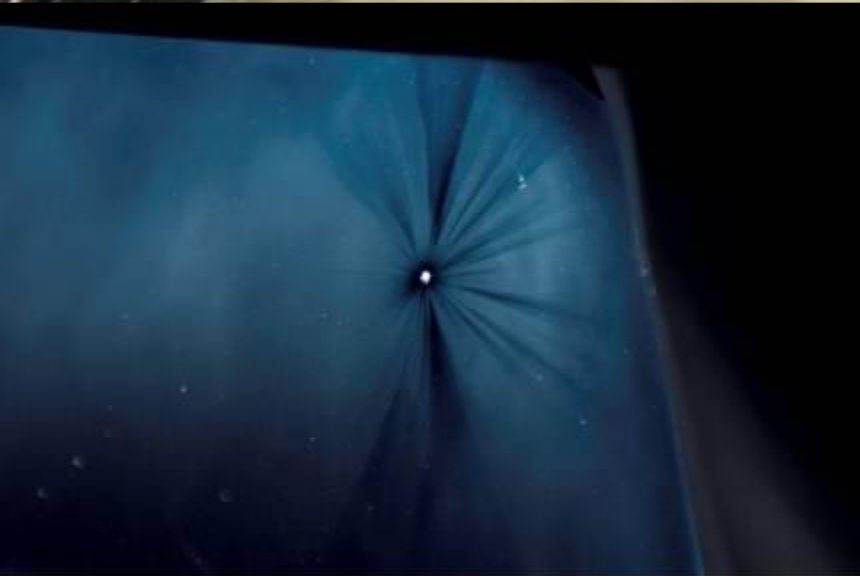
STS-123 (OV-105/Flight 21) MMOD Inspection

W1: LH side

Depth=0.389 mm (0.0153 in)
Extent=3.66x3.25 mm (0.14 x 0.13 in)

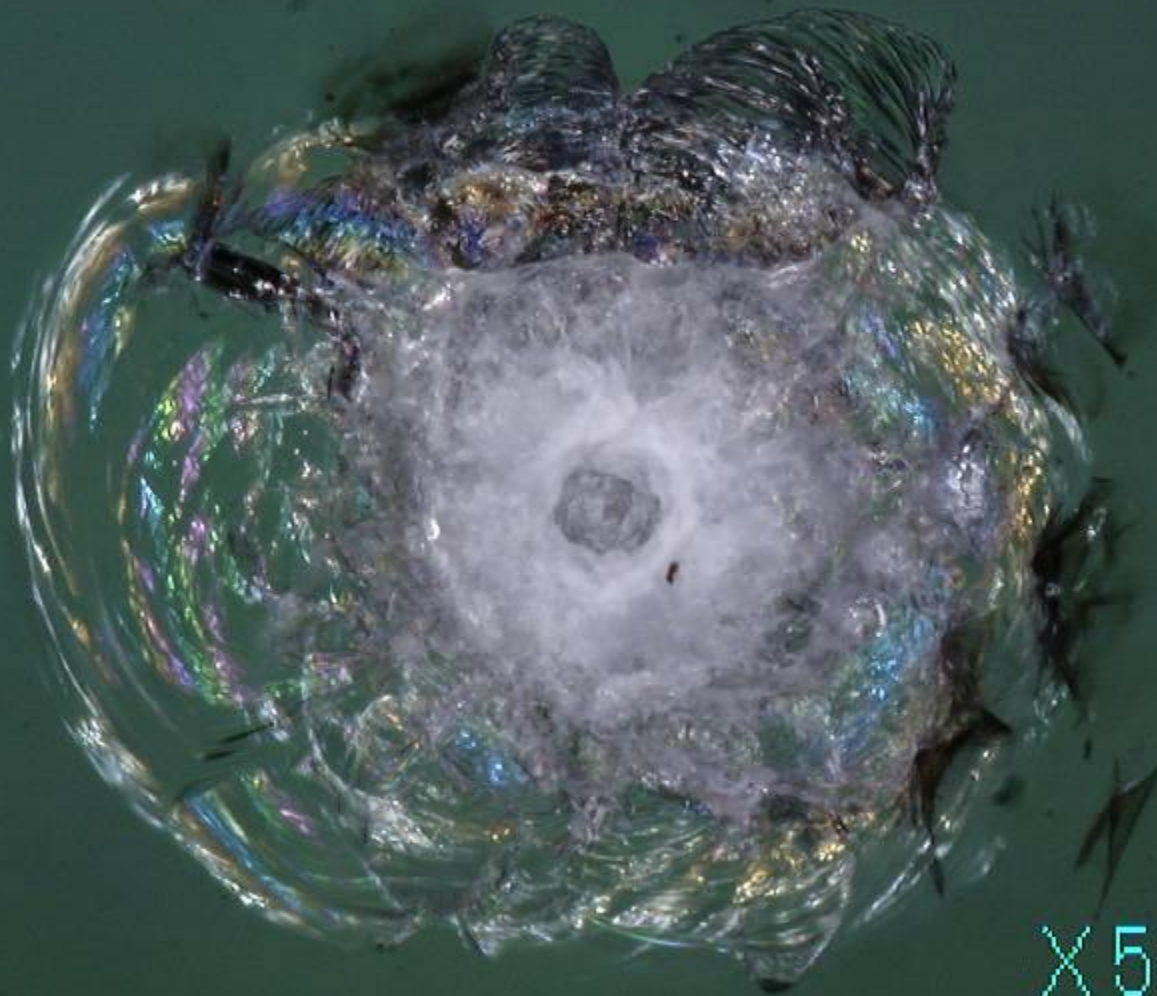
STS-123 (OV-105/Flight 20) MMOD Inspection

W1: LH side

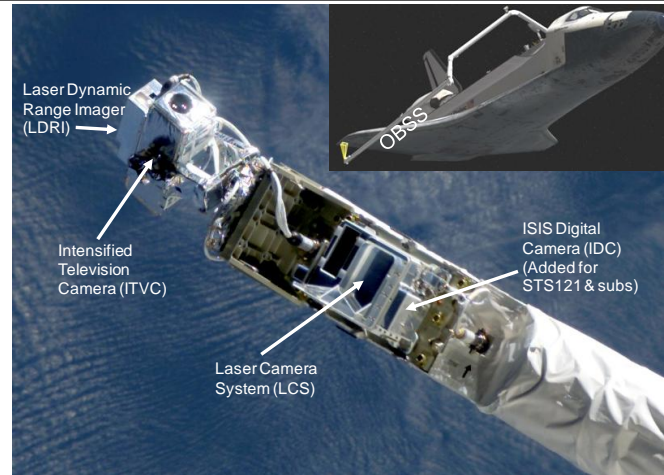
STS-134: OBSS Positioned for focused Inspection of Tile Gouge (Ascent Related Damage).

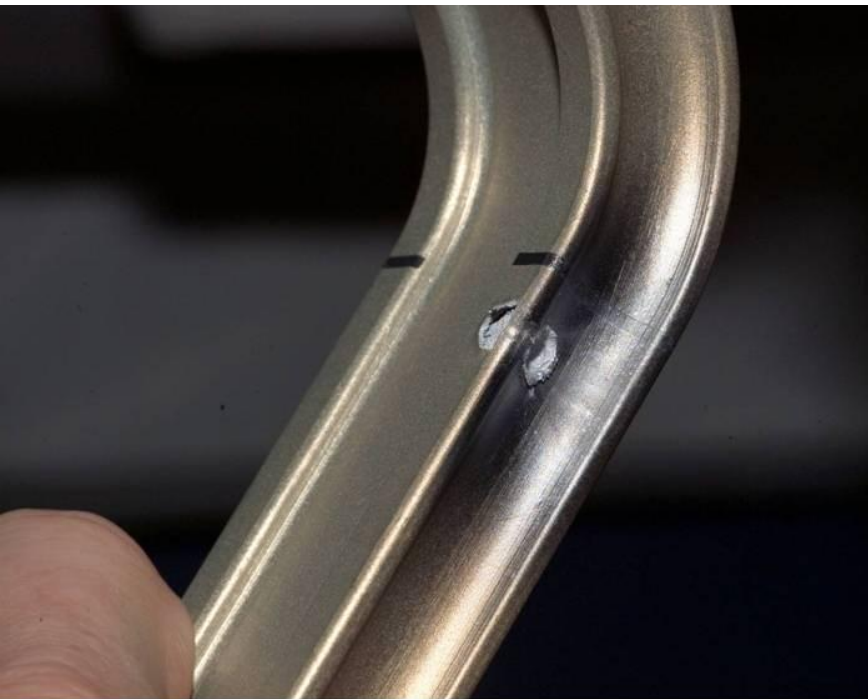
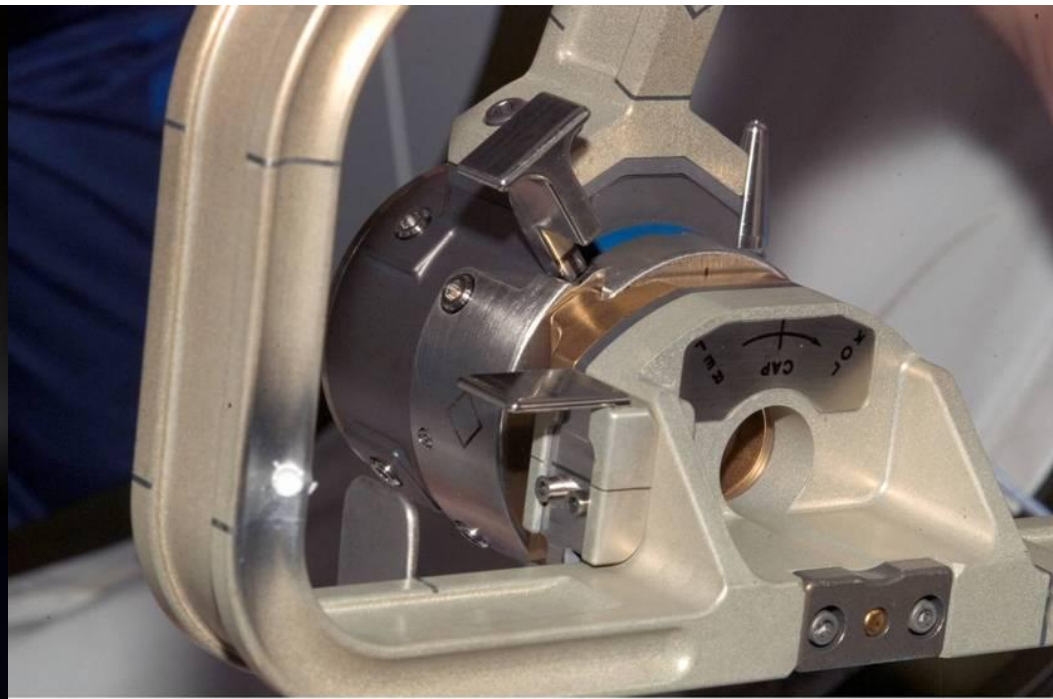
- A MMOD impact crater with detached spall found on an EVA tool (D-handle) during STS-123 (March 2008)
- D-handle stored externally on ISS Z1 Truss
- Damage repaired prior to use during STS-123 EVAs (edges filed and handle taped)

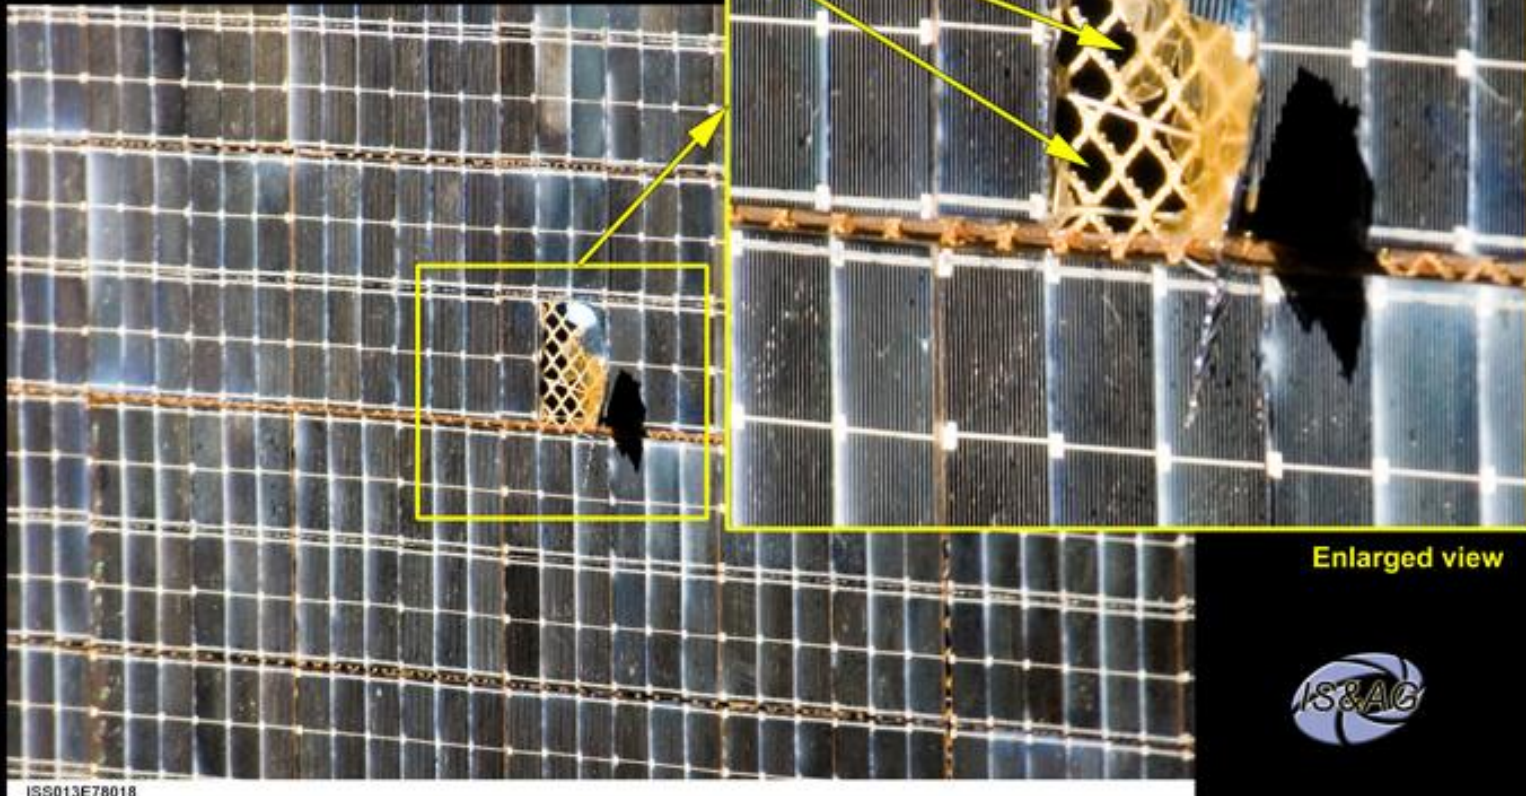
Hole in port Service Module Array
observed during STS-115
(3-4 photovoltaic cells
peeled back, revealing
lattice structure underneath)
